VOLKSWAGEN Polo: 1GAP647			
Vinnnumber:	<b>WVWZZZ6RZEY129124</b>	Versionname:	<b>POLO Comfortline DPF</b>
First Registrationdate:	<b>9/12/2013</b>	Fiscalpower:	<b>75PK</b>
Expertise Mileage:	<b>116241</b>	Power Kw:	<b>55</b>
Bodytype:		Body color:	<b>Silver</b>
Gearbox:	<b>MAN 5 VIT</b>	Paint type:	<b>Metalic</b>
Transmission:	<b>Front</b>	Rims summer:	<b>Steel</b>
Fueltype:	<b>Diesel</b>	Oil level:	<b>OK</b>
Battery functioning:	<b>Yes</b>	Parking lot:	<b>1514</b>
Number of doors:	<b>5</b>		
Number of seats:	<b>5</b>		
Number head rests:	<b>5</b>		
Rims summer:	<b>Steel</b>		
Category:	<b>Passenger Car</b>		
Oil level:	<b>OK</b>		
Registration Certificate Car (BE):	<b>Yes</b>

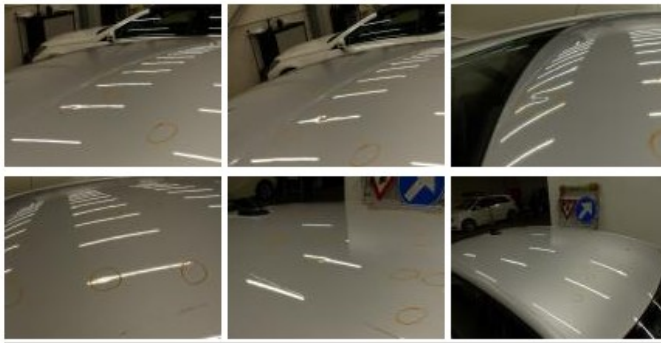
Assistance equipment			
Spare wheel	<b>Yes</b>	Jack	<b>Yes</b>
Total cost ex VAT			<b>1063,00</b>
Front bumper, Scratch(es), Acceptable			<b>0,00</b>
<i>No pictures to display</i>			
Roof, Hail damage, PDR - Hail			<b>1000,00</b>
