VOLVO V40: 1FL1840			
Vinnnumber:	YV1MV8481E2091879	Versionname:	V40 D2 Base 115PK
First Registrationdate:	6/08/2013	Fiscalpower:	
Expertise Mileage:	49751	Power Kw:	84
Bodytype:	Hatchback	Body color:	Silver
Gearbox:	MAN 6 VIT	Paint type:	Metalic
Transmission:	Front	Rims summer:	Aluminium
Fueltype:	Diesel	Oil level:	OK
Maintenance:	BINN 18153KM	Parking lot:	4306
Maintenance:	OK		
Battery functioning:	Yes		
Number of doors:	5		
Number of seats:	5		
Number head rests:	5		
Rims summer:	Aluminium		
Category:	Passenger Car		
Oil level:	OK

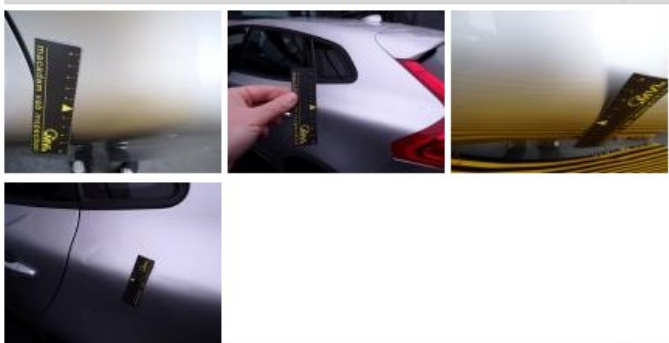
Assistance equipment			
Repair kit	No	Compressor	Yes
Total cost ex VAT			488,44
Alloy rim R L, Scratch(es), Acceptable			0,00
<i>No pictures to display</i>			
Wing R L, Bump(s), PDR - Knock out without painting			82,80
