**MERCEDES E: FU8364**

**Limited Technical Inspection**

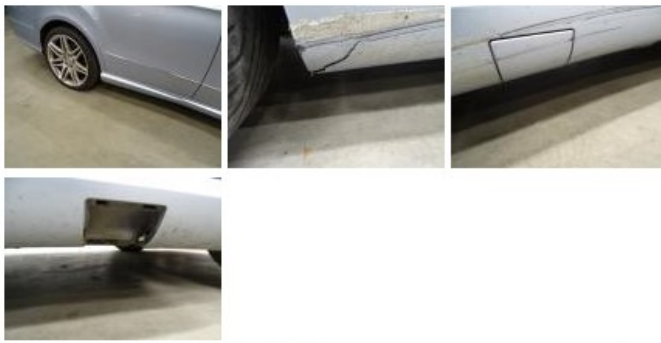
Bumper R, Scratch(es), Acceptable	0,00
<i>No pictures to display</i>	
Sill outer R, Crack, Le - Replace and paint	844,80
