AUDI A3: 1HGV230

Limited Technical Inspection

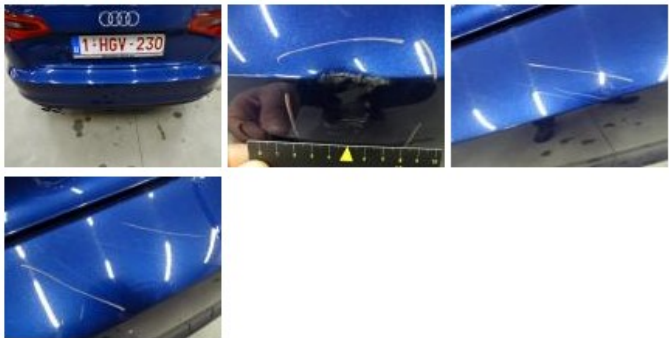
Total cost ex VAT	1050,20
Bonnet, Stone chip(s), Acceptable	0,00
<i>No pictures to display</i>	
Bumper R, Scratch(es), LI - Repair and paint (complete)	211,80
