BMW 3 TOURING: 1LNE930

Limited Technical Inspection

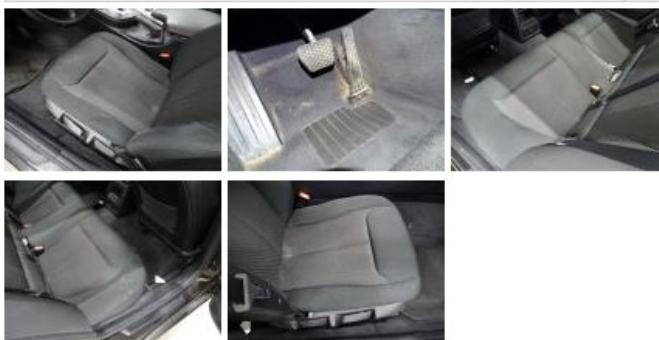
Total cost ex VAT	311,80
Alloy rim F R, Scratch(es), Acceptable	0,00
<i>No pictures to display</i>	
Interior, Dirty, Cleaning	100,00

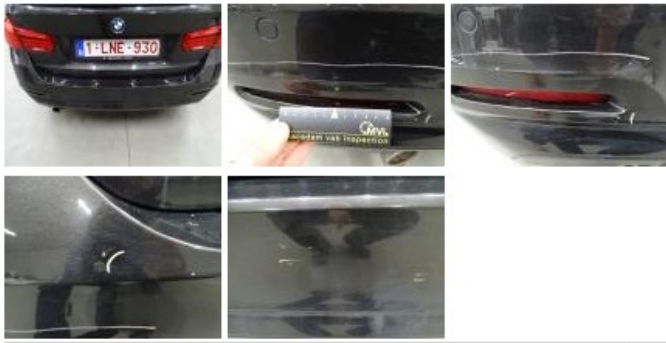
Bumper R, Scratch(es), LI - Repair and paint (complete)
211,80
