<b>VOLKSWAGEN Passat: 1HLF975</b>			
Vinnnumber:	<b>WVWZZZ3CZFE011465</b>	Versionname:	<b>PASSAT VAR Comfortline BMT DSG 105PK Aut</b>
First Registrationdate:	<b>19/08/2014</b>	Fiscalpower:	
Expertise Mileage:	<b>179415</b>	Power Kw:	<b>77</b>
Bodytype:	<b>Break</b>	Body color:	<b>Black</b>
Gearbox:	<b>Automatic</b>	Paint type:	<b>Metalic</b>
Transmission:		Rims summer:	<b>Aluminium</b>
Fueltype:	<b>Diesel</b>	Oil level:	<b>OK</b>
Battery functioning:	<b>Yes</b>	Parking lot:	<b>1121</b>
Number of doors:	<b>5</b>		
Number of seats:	<b>5</b>		
Number head rests:	<b>5</b>		
Rims summer:	<b>Aluminium</b>		
Category:	<b>Passenger Car</b>		
Oil level:	<b>OK</b>		
Registration Certificate Car (BE):	<b>Yes</b>

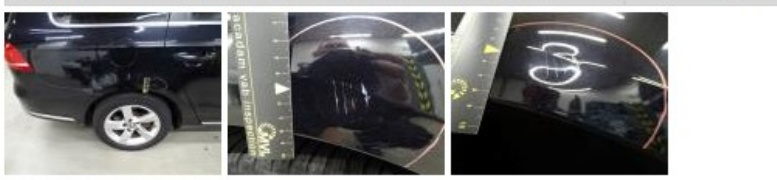
Total cost ex VAT	308,20
Bumper R, Scratch(es), Acceptable	0,00
<i>No pictures to display</i>	
Wing R R, Bump(s) and scratch(es), LI - Repair and paint (complete)	308,20
