MERCEDES B: 1GGM468			
Vinnnumber:	<b>WDD2462121J233668</b>	Versionname:	<b>B 180 CDI BE 109PK</b>
First Registrationdate:	<b>3/02/2014</b>	Fiscalpower:	
Expertise Mileage:	<b>41076</b>	Power Kw:	<b>80</b>
Bodytype:	<b>Hatchback</b>	Body color:	<b>Dark Grey</b>
Gearbox:	<b>MAN 6 VIT</b>	Paint type:	<b>Metalic</b>
Transmission:	<b>Front</b>	Rims summer:	<b>Aluminium</b>
Fueltype:	<b>Diesel</b>	Oil level:	<b>OK</b>
Battery functioning:	<b>Yes</b>	Parking lot:	<b>3409</b>
Number of doors:	<b>5</b>		
Number of seats:	<b>5</b>		
Number head rests:	<b>5</b>		
Rims summer:	<b>Aluminium</b>		
Category:	<b>Passenger Car</b>		
Oil level:	<b>OK</b>		
Registration Certificate Car (BE):	<b>Yes</b>

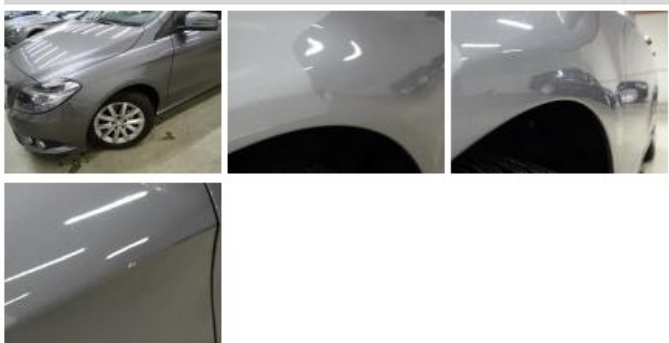
Total cost ex VAT	431,98
Wing F L, Bump(s) and scratch(es), LI - Repair and paint (complete)	220,18

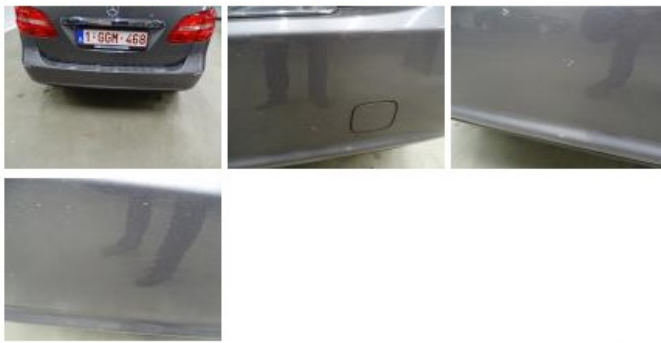
Bumper R, Scratch(es), LI - Repair and paint (complete)	211,80
---------------------------------------------------------	--------
