BMW 1: 1GCQ322

Limited Technical Inspection

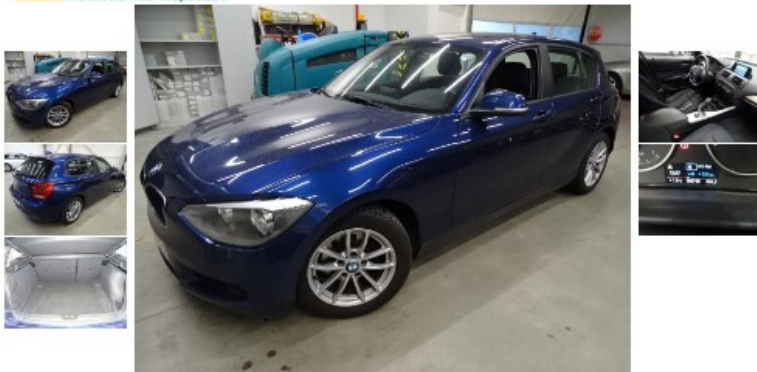
Vinnnumber:	WBA1C91040J520207	Versionname:	1 HATCH 116d Eff.Dyn.Ed. 116PK
First Registrationdate:	2/01/2014	Fiscalpower:	
Expertise Mileage:	100759	Power Kw:	85
Bodytype:		Body color:	Blue
Gearbox:	MAN 6 VIT	Paint type:	Metalic
Transmission:	Back	Rims summer:	Aluminium
Fueltype:	Diesel	Oil level:	OK
Maintenance:	OVER 8000 KM	Parking lot:	1412
Maintenance:	OK		
Battery functioning:	Yes		
Number of doors:	5		
Number of seats:	5		
Number head rests:	5		
Rims summer:	Aluminium		
Category:	Passenger Car		
Oil level:	OK		
Registration Certificate Car (BE):	Yes
