BMW 5: 1JJG285

Limited Technical Inspection

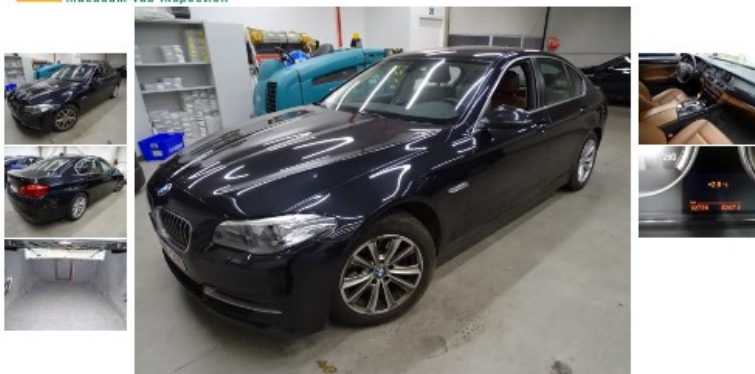
Vinnnumber:	WBA5E51010G057671	Versionname:	5 BER 520dA 163PK Aut.
First Registrationdate:	2/01/2015	Fiscalpower:	
Expertise Mileage:	92786	Power Kw:	120
Bodytype:		Body color:	Black
Gearbox:	Automatic	Paint type:	Metalic
Transmission:		Rims summer:	Aluminium
Fueltype:	Diesel	Oil level:	OK
Battery functioning:	Yes	Parking lot:	4812
Number of doors:	4		
Number of seats:	5		
Number head rests:	5		
Rims summer:	Aluminium		
Category:	Passenger Car		
Oil level:	OK		
Registration Certificate Car (BE):	No
