VOLVO XC60: 1GUM229

Limited Technical Inspection

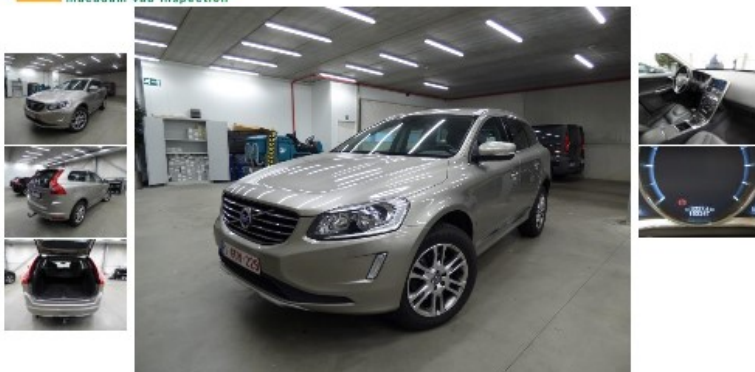
Vinnumber:	YV1DZ31A1E2616690	Versionname:	
First Registrationdate:	5/05/2014	Fiscalpower:	
Expertise Mileage:	153247	Power Kw:	100
Bodytype:	SUV	Body color:	Grey
Gearbox:	MAN 6 VIT	Paint type:	Metalic
Transmission:		Rims summer:	Aluminium
Fueltype:	Diesel	Oil level:	OK
Battery functioning:	Yes	Parking lot:	3116
Number of doors:	5		
Number of seats:	5		
Number head rests:	5		
Rims summer:	Aluminium		
Category:	Passenger Car		
Oil level:	OK		
Registration Certificate Car (BE):	Yes
