AUDI A4: 1GAQ904			
Vinnumber:	<b>WAUZZZ8K0EA081474</b>	Versionname:	<b>A4 BER TDie 136PK</b>
First Registrationdate:	<b>9/12/2013</b>	Fiscalpower:	
Expertise Mileage:	<b>135066</b>	Power Kw:	<b>100</b>
Bodytype:	<b>Berline</b>	Body color:	<b>Dark Grey</b>
Gearbox:	<b>MAN 6 VIT</b>	Paint type:	<b>Metalic</b>
Transmission:	<b>Front</b>	Rims summer:	<b>Aluminium</b>
Fueltype:	<b>Diesel</b>	Oil level:	<b>OK</b>
Battery functioning:	<b>Yes</b>	Parking lot:	<b>3121</b>
Number of doors:	<b>4</b>		
Number of seats:	<b>5</b>		
Number head rests:	<b>5</b>		
Rims summer:	<b>Aluminium</b>		
Category:	<b>Passenger Car</b>		
Oil level:	<b>OK</b>		
Registration Certificate Car (BE):	<b>Yes</b>

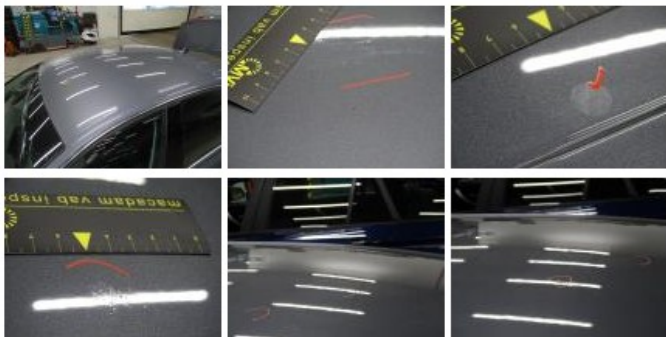
Assistance equipment			
Repair kit	<b>Yes</b>	Compressor	<b>Yes</b>
Total cost ex VAT			1169,26
Roof, Chemical polution, LI - Repair and paint (complete)			529,50
