CITROËN Berlingo: TZ7671	
Vinnumber:	VF77B9HN0CN544483
First Registrationdate:	6/02/2013
Expertise Mileage:	192833
Bodytype:	Transporter
Gearbox:	MAN 5 VIT
Transmission:	Front
Fueltype:	Diesel
Battery functioning	Yes
Number of doors	5
Number of seats	3
Number head rests	3
Rims summer	Steel
Category	Light Commercial Vehicle
Oil level	OK
Registration Certificate Car (BE)	Yes
Versionname:	BERLINGO B/F Kort Fresh
Fiscalpower:	75PK
Power Kw:	55
Body color	White
Paint type	Opaque
Rims summer	Steel
Oil level	OK
Parking lot	1620

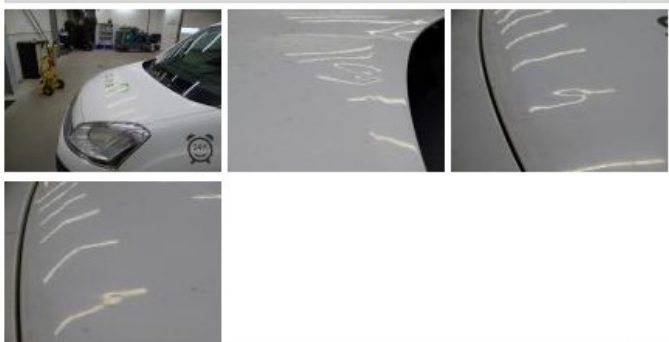
Assistance equipment	
Spare wheel	Yes Jack Yes
Total cost ex VAT	1024,01
Wing R R, Bump(s), Acceptable	0,00
<i>No pictures to display</i>	
Bodywork, Not original part, Acceptable	0,00
<i>No pictures to display</i>	
Bonnet, Bump(s), LI - Repair and paint (complete)	217,56
