BMW 5: 1HPT604			
Vinnumber:	WBA5E310X0D672550	Versionname:	5 BER 518d 136PK
First Registrationdate:	8/09/2014	Fiscalpower:	
Expertise Mileage:	40099	Power Kw:	100
Bodytype:	Berline	Body color:	Dark Grey
Gearbox:	MAN 6 VIT	Paint type:	Metalic
Transmission:	Back	Rims summer:	Aluminium
Fueltype:	Diesel	Oil level:	OK
Battery functioning:	Yes	Parking lot:	1229
Number of doors:	5		
Number of seats:	5		
Number head rests:	5		
Rims summer:	Aluminium		
Category:	Passenger Car		
Oil level:	OK		
Registration Certificate Car (BE):	Yes

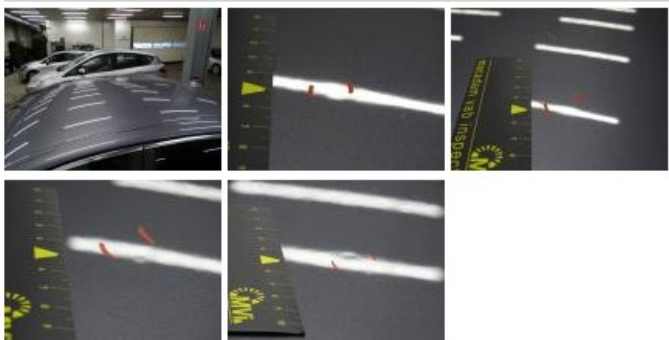
Assistance equipment			
Repair kit	Yes	Compressor	Yes
Total cost ex VAT			557,02
Roof, Hail damage, PDR - Hail			100,00

Roof, Bad repair, Paint	0,00
-------------------------	-------------
