MERCEDES C: 1EEC470			
Vinnumber:	<b>WDD2040021A804107</b>	Versionname:	<b>C BER 220 CDI BlueEFF. S&amp;S 163PK</b>
First Registrationdate:	<b>5/11/2012</b>	Fiscalpower:	
Expertise Mileage:	<b>117252</b>	Power Kw:	<b>120</b>
Bodytype:		Body color:	<b>Grey</b>
Gearbox:	<b>MAN 6 VIT</b>	Paint type:	<b>Metalic</b>
Transmission:		Rims summer:	<b>Aluminium</b>
Fueltype:	<b>Diesel</b>	Oil level:	<b>OK</b>
Battery functioning:	<b>Yes</b>	Parking lot:	<b>2402</b>
Number of doors:	<b>4</b>		
Number of seats:	<b>5</b>		
Number head rests:	<b>5</b>		
Rims summer:	<b>Aluminium</b>		
Category:	<b>Passenger Car</b>		
Oil level:	<b>OK</b>

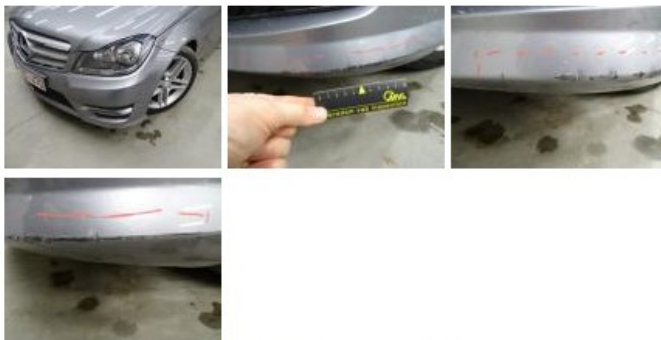
Wing F R, Scratch(es), Acceptable	<b>0,00</b>
<i>No pictures to display</i>	
Front bumper, Scratch(es), LI - Repair and paint (complete)	<b>211,80</b>

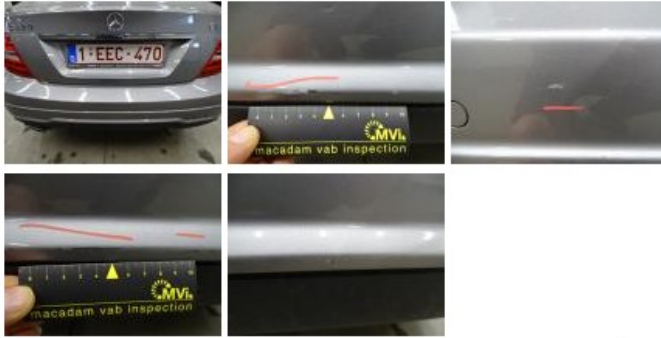
Bumper R, Scratch(es), LI - Repair and paint (complete) 211,80
