**SKODA Octavia: 1EDW982**

**Limited Technical Inspection**

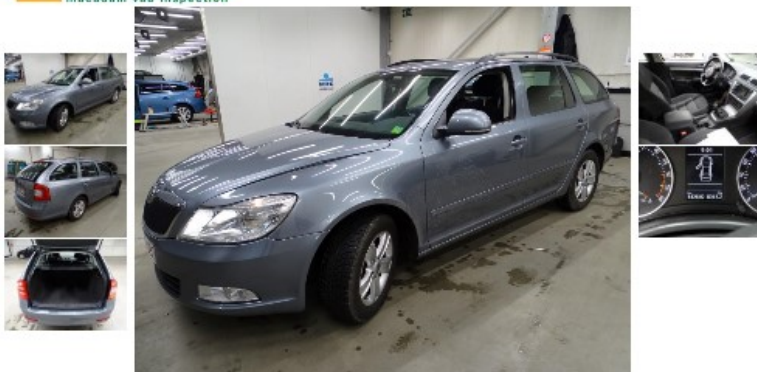
Vinnnumber:	<b>TMBHT21Z9D2075356</b>	Versionname:	<b>OCTAVIA COMBI GTec Ambition DPF 105PK</b>
First Registrationdate:	<b>2/11/2012</b>	Fiscalpower:	
Expertise Mileage:	<b>142840</b>	Power Kw:	<b>77</b>
Bodytype:	<b>Berline</b>	Body color:	<b>Grey</b>
Gearbox:	<b>MAN 5 VIT</b>	Paint type:	<b>Metalic</b>
Transmission:	<b>Front</b>	Rims summer:	<b>Aluminium</b>
Fueltype:	<b>Diesel</b>	Oil level:	<b>OK</b>
Battery functioning:	<b>Yes</b>	Parking lot:	<b>2632</b>
Number of doors:	<b>4</b>		
Number of seats:	<b>5</b>		
Number head rests:	<b>5</b>		
Rims summer:	<b>Aluminium</b>		
Category:	<b>Passenger Car</b>		
Oil level:	<b>OK</b>
