BMW 3: 1GHF467

Vinnnumber:	WBA3D11020J625996	Versionname:	3 BER 318d 136PK
First Registrationdate:	7/02/2014	Fiscalpower:	
Expertise Mileage:	54537	Power Kw:	100
Bodytype:		Body color:	Grey
Gearbox:	MAN 6 VIT	Paint type:	Metalic
Transmission:		Rims summer:	Aluminium
Fueltype:	Diesel	Oil level:	OK
Battery functioning:	Yes	Parking lot:	3615
Number of doors:	5		
Number of seats:	5		
Number head rests:	5		
Rims summer:	Aluminium		
Category:	Passenger Car		
Oil level:	OK		
Registration Certificate Car (BE):	Yes

Limited Technical Inspection

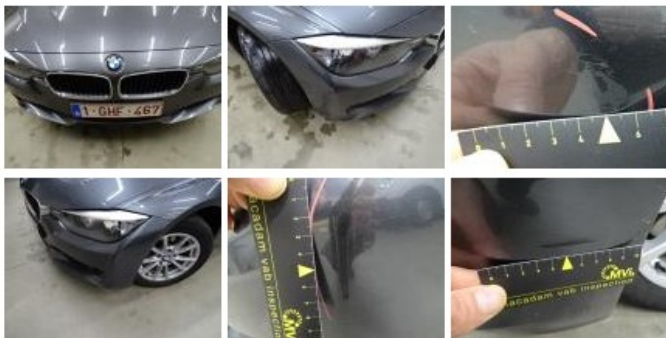
Repair kit	Yes	Compressor	Yes
Total cost ex VAT			635,56
Front bumper, Scratch(es), LI - Repair and paint (complete)			211,80
