BMW 1: 1FGU439

Limited Technical Inspection

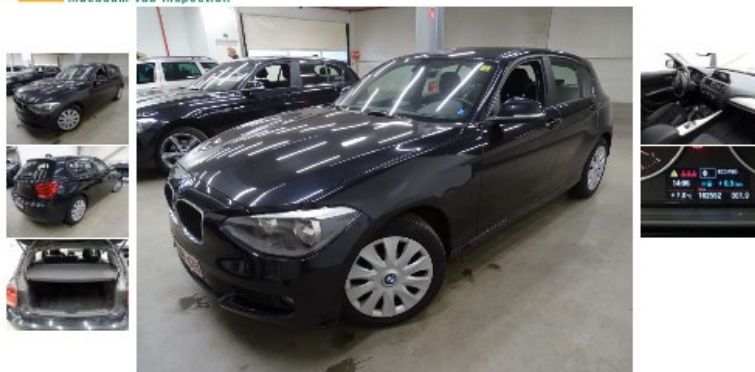
Vinnumber:	WBA1C91020J513286	Versionname:	1 HATCH 116d Eff.Dyn.Ed. 116PK
First Registrationdate:	25/06/2013	Fiscalpower:	
Expertise Mileage:	162552	Power Kw:	85
Bodytype:	Berline	Body color:	Black
Gearbox:	MAN 6 VIT	Paint type:	Metalic
Transmission:	Back	Rims summer:	Steel
Fueltype:	Diesel	Oil level:	OK
Maintenance:	OK	Parking lot:	3427
Maintenance:	DANS 11000 KM		
Battery functioning:	Yes		
Number of doors:	5		
Number of seats:	5		
Number head rests:	5		
Rims summer:	Steel		
Category:	Passenger Car		
Oil level:	OK
