<b>HYUNDAI i20: 1RKG940</b>			
Vinnnumber:	<b>NLHB251PAHZ258192</b>	Versionname:	<b>i20 5 doors V5b - 1.1 D M6</b>
First Registrationdate:	<b>11/01/2017</b>	Fiscalpower:	<b>75 - Air</b>
Expertise Mileage:	<b>12941</b>	Power Kw:	
Bodytype:		Body color	<b>Brown</b>
Gearbox:	<b>MAN 6 VIT</b>	Paint type	<b>Metalic</b>
Transmission:		Rims summer	<b>Steel</b>
Fueltype:	<b>Diesel</b>	Oil level	<b>OK</b>
Battery functioning	<b>Yes</b>	Parking lot	<b>1325</b>
Number of doors	<b>5</b>		
Number of seats	<b>5</b>		
Number head rests	<b>5</b>		
Rims summer	<b>Steel</b>		
Category	<b>Passenger Car</b>		
Oil level	<b>OK</b>

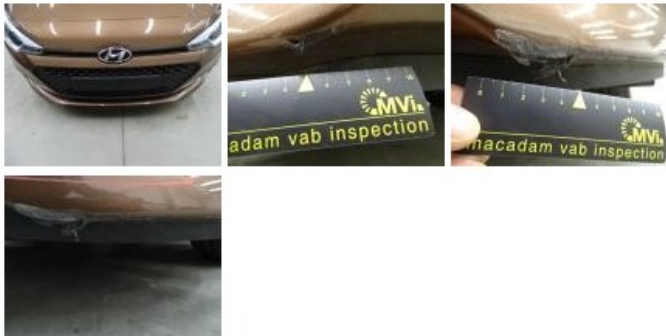
<b>Assistance equipment</b>			
Repair kit	<b>Yes</b>	Compressor	<b>Yes</b>
Total cost ex VAT			<b>363,88</b>
Front bumper, Scratch(es), LI - Repair and paint (complete)			<b>169,44</b>
