VOLVO XC60: 1FAY506			
Vinnumber:	YV1DZ31A1D2461219	Versionname:	XC60 D3 Kinetic Start/Stop 136PK
First Registrationdate:	13/05/2013	Fiscalpower:	
Expertise Mileage:	205162	Power Kw:	100
Bodytype:		Body color	Dark Blue
Gearbox:	MAN 6 VIT	Paint type	Metalic
Transmission:		Rims summer	Aluminium
Fueltype:	Diesel	Oil level	OK
Battery functioning	Yes	Parking lot	2425
Number of doors	5		
Number of seats	5		
Number head rests	5		
Rims summer	Aluminium		
Category	Passenger Car		
Oil level	OK

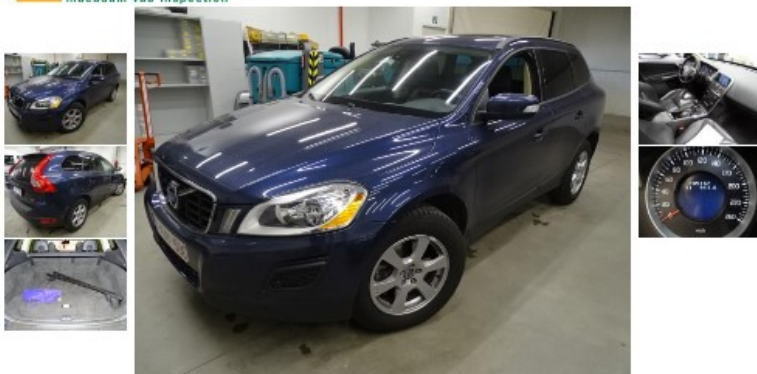
Assistance equipment			
Repair kit	Yes	Compressor	Yes
Total cost ex VAT			382,02
Front bumper, Scratch(es), Acceptable			0,00
<i>No pictures to display</i>			
Rocker panel inner R L, Scratch(es), Acceptable			0,00
<i>No pictures to display</i>			
Door F R, Bump(s) and scratch(es), LI - Repair and paint (complete)			382,02
