BMW 3: 1EVN491			
Vinnumber:	WBA3D11060J621823	Versionname:	3 BER 318d 136PK
First Registrationdate:	1/04/2013	Fiscalpower:	
Expertise Mileage:	179361	Power Kw:	100
Bodytype:		Body color:	Brown
Gearbox:	MAN 6 VIT	Paint type:	Metalic
Transmission:		Rims summer:	Aluminium
Fueltype:	Diesel	Oil level:	OK
Battery functioning:	Yes	Parking lot:	2533
Number of doors:	4		
Number of seats:	5		
Number head rests:	5		
Rims summer:	Aluminium		
Category:	Passenger Car		
Oil level:	OK

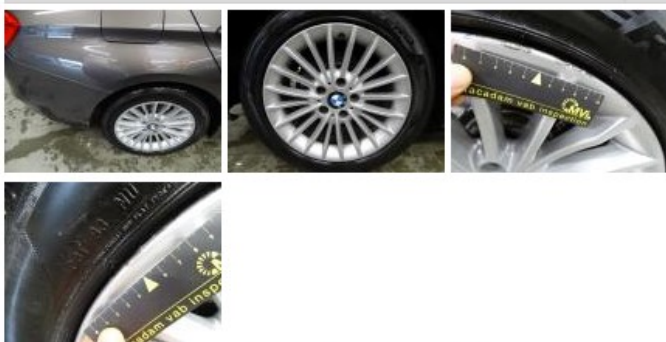
Assistance equipment	
Runflat	Yes
Total cost ex VAT	498,20
Alloy rim R R, Scratch(es), LI - Repair and paint (complete)	95,00
