VOLVO V40: 1GSD283

Limited Technical Inspection

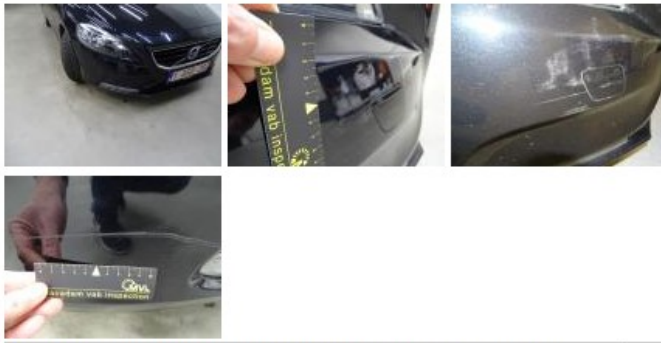
Front bumper, Bump(s) and scratch(es), LI - Repair and paint (complete)	211,80
-------------------------------------------------------------------------	--------
