BMW 3: 1GQH813

Limited Technical Inspection

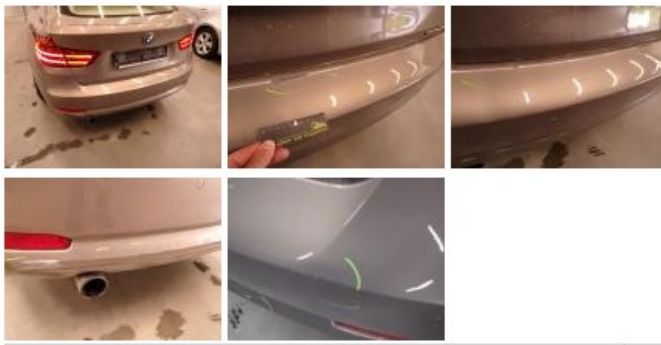
Repair kit	Yes	Compressor	Yes
Total cost ex VAT			409,80
Door R R, Bump(s), Acceptable			0,00
<i>No pictures to display</i>			
Ignition key, Incomplete, E - Replace			150,00
<i>No pictures to display</i>			
Seat cover F L, Tear, Acceptable			0,00
<i>No pictures to display</i>			
Bumper R, Bump(s) and scratch(es), LI - Repair and paint (complete)			259,80

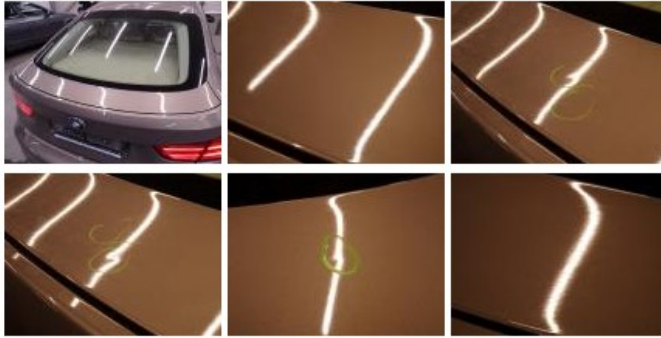
Tailgate, Bad repair, Acceptable 0,00
