**OPEL Astra: 1CDU115**

**Limited Technical Inspection**

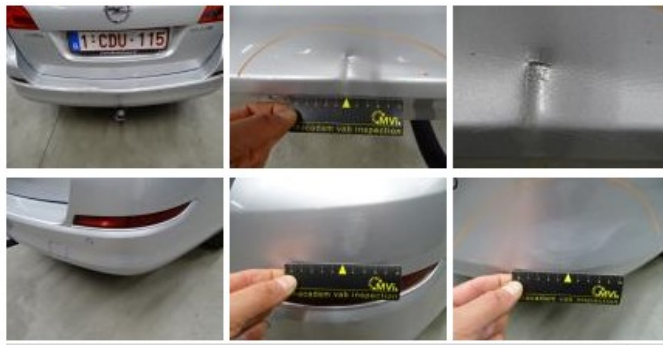
Front bumper, Scratch(es), Acceptable	0,00
<i>No pictures to display</i>	
Wing R L, Scratch(es), Acceptable	0,00
<i>No pictures to display</i>	
Bumper R, Bump(s) and scratch(es), LI - Repair and paint (complete)	211,80

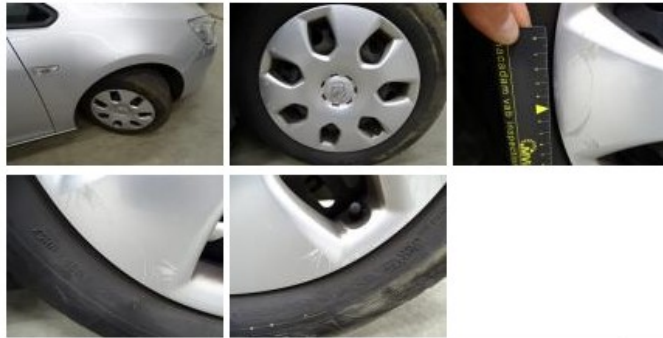
Door F L, Scratch(es), Acceptable	0,00
<i>No pictures to display</i>	
Door R L, Scratch(es), Acceptable	0,00
<i>No pictures to display</i>	
Wheel cover F R, Scratch(es), E - Replace	30,00
