RENAULT Scenic: 1FXB963

Limited Technical Inspection

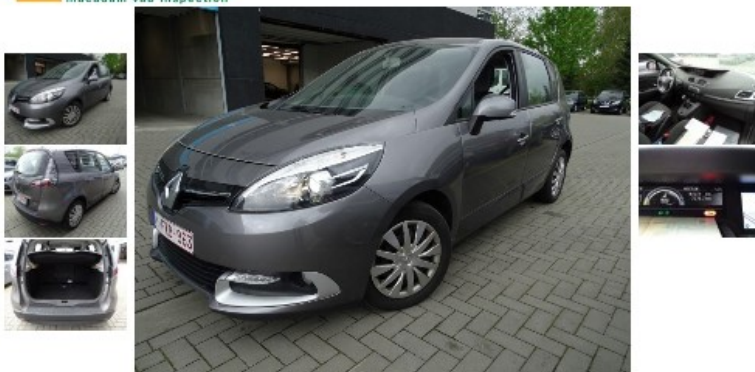
Vinnumber:	VF1JZT20649892257	Versionname:	SCENIC Life 95PK
First Registrationdate:	25/11/2013	Fiscalpower:	
Expertise Mileage:	87273	Power Kw:	70
Bodytype:		Body color	Dark Grey
Gearbox:	MAN 6 VIT	Paint type	Metalic
Transmission:	Front	Rims summer	Steel
Fueltype:	Diesel	Oil level	OK
Battery functioning	Yes	Parking lot	2604
Number of doors	5		
Number of seats	5		
Number head rests	5		
Rims summer	Steel		
Category	Passenger Car		
Oil level	OK		
Registration Certificate Car (BE)	Yes
