BMW 3: 1FVT958			
Vinnumber:	WBA3K11020F828783	Versionname:	3 TOURING 318d 136PK
First Registrationdate:	12/11/2013	Fiscalpower:	
Expertise Mileage:	161874	Power Kw:	100
Bodytype:	Break	Body color:	White
Gearbox:	MAN 6 VIT	Paint type:	Metalic
Transmission:		Rims summer:	Aluminium
Fueltype:	Diesel	Oil level:	OK
Battery functioning:	Yes	Parking lot:	3109
Number of doors:	5		
Number of seats:	5		
Number head rests:	5		
Rims summer:	Aluminium		
Category:	Passenger Car		
Oil level:	OK		
Registration Certificate Car (BE):	Yes

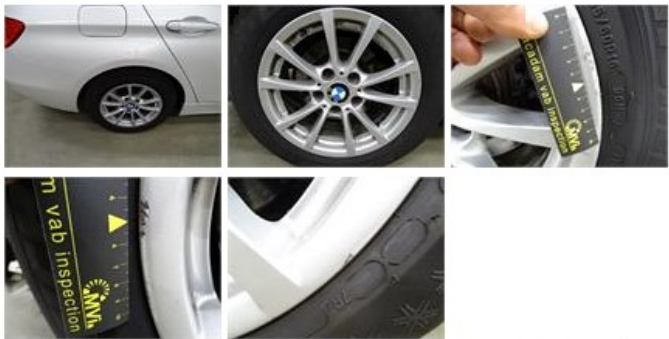
Assistance equipment			
Repair kit	Yes	Compressor	Yes
Total cost ex VAT			1137,30
Alloy rim R R, Scratch(es), LI - Repair and paint (complete)			95,00
