BMW 5: 1EPZ647

Limited Technical Inspection

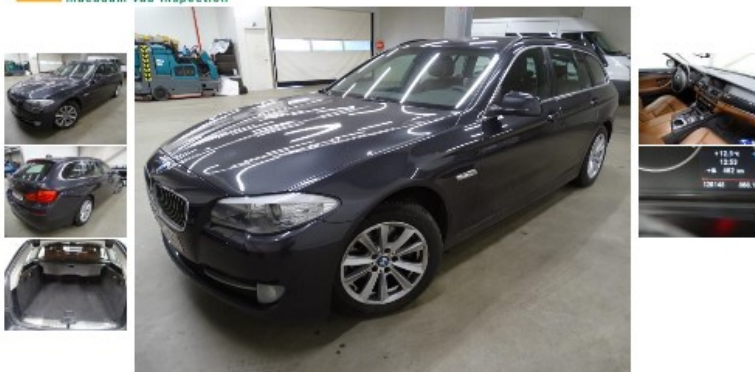
Total cost ex VAT	433,16
Windscreen, Stone chip(s), Acceptable	0,00
<i>No pictures to display</i>	
Door F R, Scratch(es), Acceptable	0,00
<i>No pictures to display</i>	
Wing R R, Scratch(es), Acceptable	0,00
<i>No pictures to display</i>	
Bumper R, Damaged, E - Replace	84,00
