**MERCEDES A: 1EYH119**

**Limited Technical Inspection**

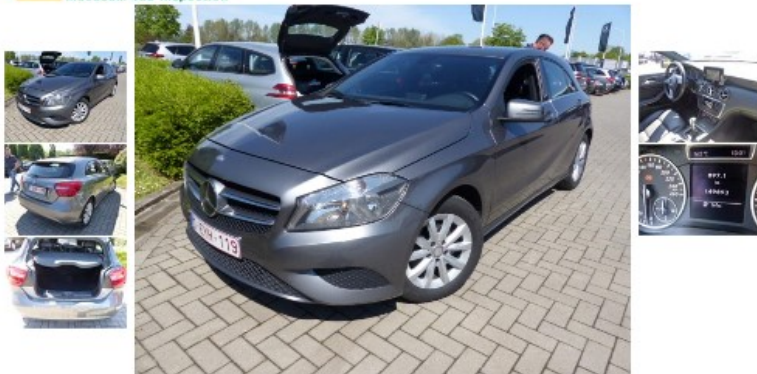
Vinnnumber:	<b>WDD1760121J071721</b>	Versionname:	<b>A 180 CDI BE 109PK</b>
First Registrationdate:	<b>19/04/2013</b>	Fiscalpower:	
Expertise Mileage:	<b>149893</b>	Power Kw:	<b>80</b>
Bodytype:		Body color:	<b>Grey</b>
Gearbox:	<b>MAN 6 VIT</b>	Paint type:	<b>Metalic</b>
Transmission:	<b>Front</b>	Rims summer:	<b>Aluminium</b>
Fueltype:	<b>Diesel</b>	Oil level:	<b>OK</b>
Battery functioning:	<b>Yes</b>		
Number of doors:	<b>5</b>		
Number of seats:	<b>5</b>		
Number head rests:	<b>5</b>		
Rims summer:	<b>Aluminium</b>		
Category:	<b>Passenger Car</b>		
Oil level:	<b>OK</b>
