AUDI A3: 1GVQ877

Limited Technical Inspection

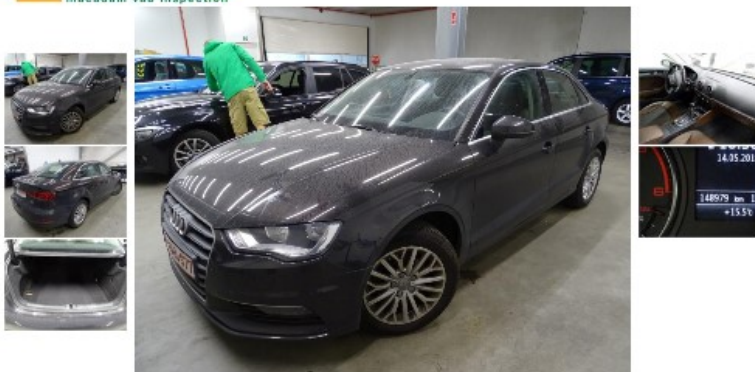
Vinnnumber:	WAUZZZ8V7E1038325	Versionname:	A3 SED Ambiente 105PK
First Registrationdate:	13/05/2014	Fiscalpower:	
Expertise Mileage:	148979	Power Kw:	77
Bodytype:	Berline	Body color:	Dark Brown
Gearbox:	MAN 6 VIT	Paint type:	Metalic
Transmission:	Front	Rims summer:	Aluminium
Fueltype:	Diesel	Oil level:	OK
Battery functioning:	Yes	Parking lot:	2415
Number of doors:	4		
Number of seats:	5		
Number head rests:	5		
Rims summer:	Aluminium		
Category:	Passenger Car		
Oil level:	OK		
Registration Certificate Car (BE):	Yes
