BMW 3: 1EXQ609			
Vinnumber:	WBA3K91080F929891	Versionname:	3 TOURING 316d 116PK
First Registrationdate:	16/04/2013	Fiscalpower:	
Expertise Mileage:	121705	Power Kw:	85
Bodytype:	Break	Body color:	Light Grey
Gearbox:	MAN 6 VIT	Paint type:	Metalic
Transmission:		Rims summer:	Steel
Fueltype:	Diesel	Oil level:	OK
Battery functioning:	Yes	Parking lot:	2621
Number of doors:	5		
Number of seats:	5		
Number head rests:	5		
Rims summer:	Steel		
Category:	Passenger Car		
Oil level:	OK

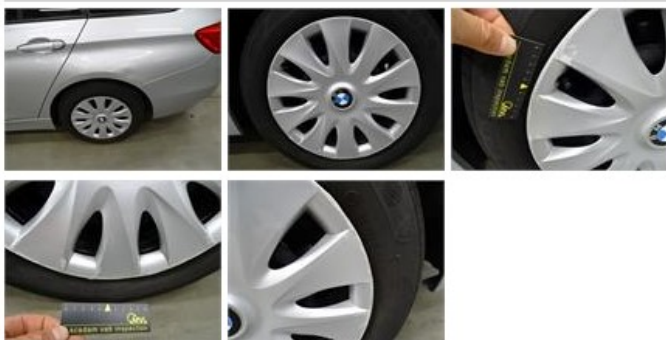
Assistance equipment			
Repair kit	Yes	Compressor	Yes
Total cost ex VAT			610,00
Wheel cover R L, Scratch(es), E - Replace			30,00
