BMW 3: 1GUZ440

Limited Technical Inspection

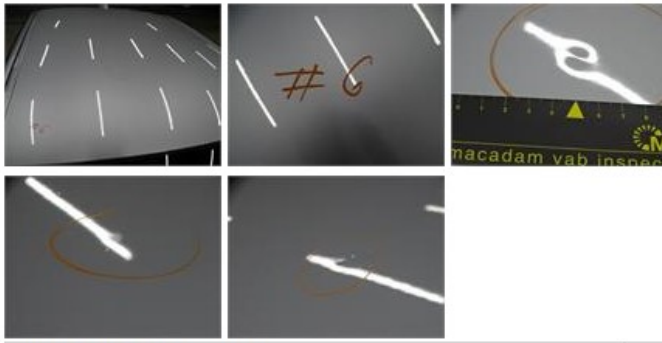
Runflat	Yes
Total cost ex VAT		150,00
Bumper R, Scratch(es), Acceptable		0,00
<i>No pictures to display</i>		
Front bumper, Scratch(es), Acceptable		0,00
<i>No pictures to display</i>		
Alloy rim F L, Scratch(es), Acceptable		0,00
<i>No pictures to display</i>		
Door R L, Scratch(es), Acceptable		0,00
<i>No pictures to display</i>		
Alloy rim R R, Scratch(es), Acceptable		0,00
<i>No pictures to display</i>		
Roof, Hail damage, PDR - Hail		150,00
