VOLVO V60: 1FXK513

Limited Technical Inspection

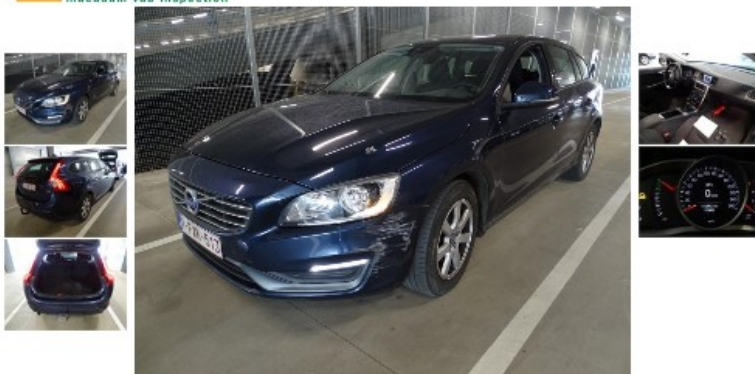
Vinnnumber:	YV1FW8481E1180329	Versionname:	V60 BRE D2 Kinetic 115PK
First Registrationdate:	27/11/2013	Fiscalpower:	
Expertise Mileage:	172982	Power Kw:	84
Bodytype:		Body color:	Dark Blue
Gearbox:	MAN 6 VIT	Paint type:	Metalic
Transmission:	Front	Rims summer:	Aluminium
Fueltype:	Diesel	Oil level:	OK
Maintenance:	OK	Parking lot:	3601
Battery functioning:	Yes		
Number of doors:	5		
Number of seats:	5		
Number head rests:	5		
Rims summer:	Aluminium		
Category:	Passenger Car		
Oil level:	OK		
Registration Certificate Car (BE):	Yes
