BMW 3: 1GUH001

Limited Technical Inspection

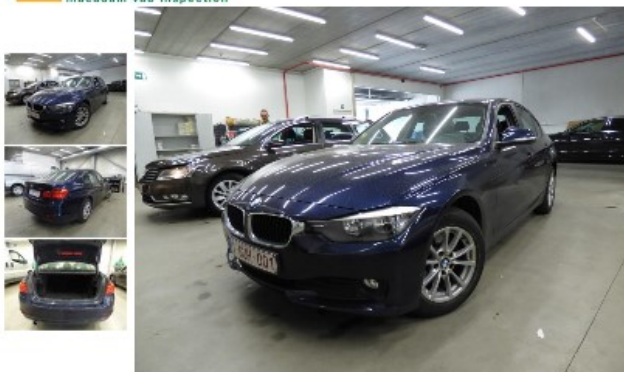
Vinnumber:	WBA3J31090F813373	Versionname:	3 BER 318dX 143PK
First Registrationdate:	2/05/2014	Fiscalpower:	
Expertise Mileage:	71909	Power Kw:	105
Bodytype:		Body color:	Blue
Gearbox:	MAN 6 VIT	Paint type:	Metalic
Transmission:	Back	Rims summer:	Aluminium
Fueltype:	Diesel	Oil level:	OK
Maintenance:	OK	Parking lot:	3621
Battery functioning:	Yes		
Number of doors:	4		
Number of seats:	5		
Number head rests:	5		
Rims summer:	Aluminium		
Category:	Passenger Car		
Oil level:	OK		
Registration Certificate Car (BE):	Yes
