BMW 3: 1GQZ818

Limited Technical Inspection

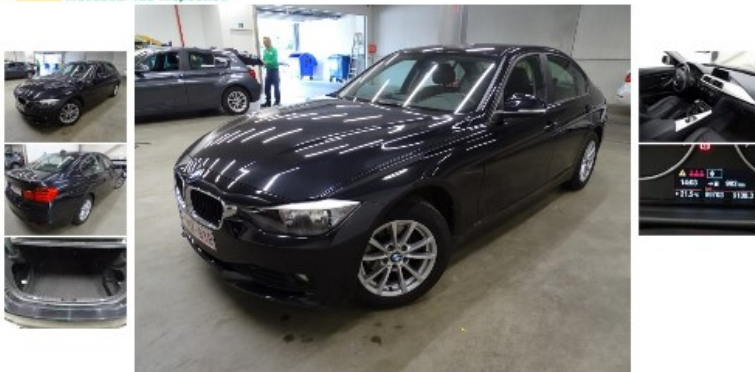
Vinnumber:	WBA3D11040J624798	Versionname:	3 BER 318d 136PK
First Registrationdate:	4/04/2014	Fiscalpower:	
Expertise Mileage:	89703	Power Kw:	100
Bodytype:	Berline	Body color:	Black
Gearbox:	MAN 6 VIT	Paint type:	Metalic
Transmission:	Back	Rims summer:	Aluminium
Fueltype:	Diesel	Oil level:	OK
Battery functioning:	Yes	Parking lot:	3124
Number of doors:	4		
Number of seats:	5		
Number head rests:	5		
Rims summer:	Aluminium		
Category:	Passenger Car		
Oil level:	OK		
Registration Certificate Car (BE):	Yes
