LEXUS RX: 1KBL447

Limited Technical Inspection

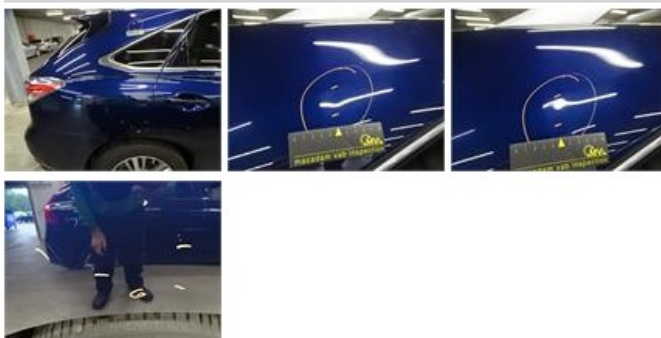
Wing R R, Bump(s) and scratch(es), LI - Repair and paint (complete) 369,84

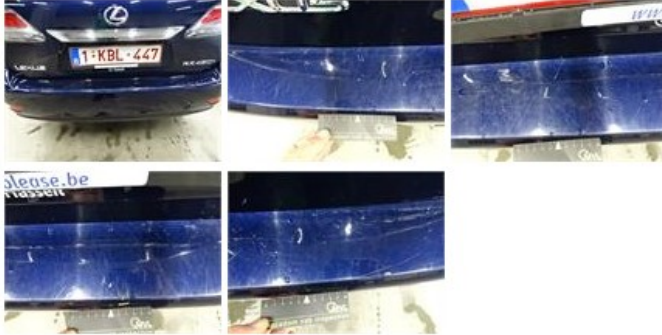
Door R R, Scratch(es), Acceptable	0,00
<i>No pictures to display</i>	
Wing F R, Scratch(es), Acceptable	0,00
<i>No pictures to display</i>	
Bumper R, Scratch(es), LI - Repair and paint (complete)	254,16
