RENAULT Scenic: 1EUU600			
Vinnnumber:	VF1JZ140648624239	Versionname:	SCENIC Energ.Privilège 110PK
First Registrationdate:	26/03/2013	Fiscalpower:	
Expertise Mileage:	121651	Power Kw:	81
Bodytype:	Hatchback	Body color	Burgundy
Gearbox:	MAN 6 VIT	Paint type	Metalic
Transmission:	Front	Rims summer	Aluminium
Fueltype:	Diesel	Oil level	OK
Battery functioning	Yes	Parking lot	3224
Number of doors	5		
Number of seats	5		
Number head rests	5		
Rims summer	Aluminium		
Category	Passenger Car		
Oil level	OK

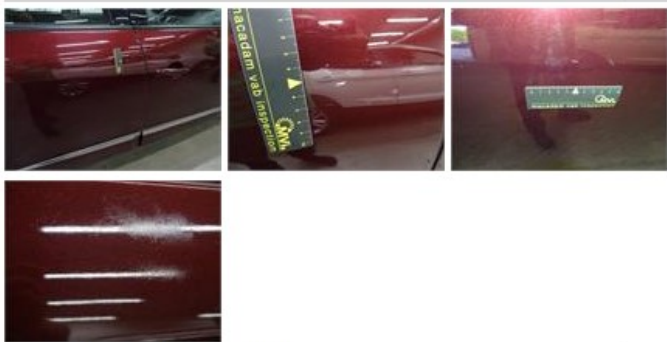
Assistance equipment			
Emergency spare wheel	Yes	Jack	Yes
Total cost ex VAT			494,98
Door R R, Bump(s) and scratch(es), LI - Repair and paint (complete)			0,00
