**BMW 5: 1EZH142**

**Limited Technical Inspection**

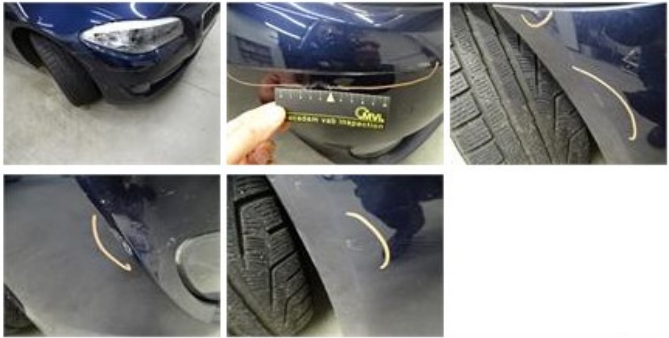
Tailgate, Scratch(es), Acceptable	0,00
<i>No pictures to display</i>	
Wing R L, Scratch(es), Acceptable	0,00
<i>No pictures to display</i>	
Front bumper, Scratch(es), LI - Repair and paint (complete)	254,16
