RENAULT Clio: 1HAU120

Limited Technical Inspection

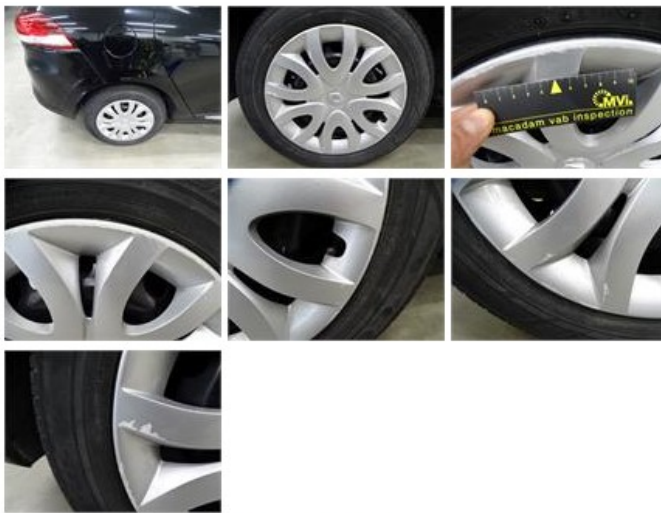
Total cost ex VAT	308,64
Tailgate, Scratch(es), Acceptable	0,00
<i>No pictures to display</i>	
Wheel cover F R, Scratch(es), Acceptable	0,00
<i>No pictures to display</i>	
Wing R R, Scratch(es), Acceptable	0,00
<i>No pictures to display</i>	
Ignition key, Missing, E - Replace	150,00
<i>No pictures to display</i>	
Wing R L, Scratch(es), Acceptable	0,00
<i>No pictures to display</i>	
Wheel cover R R, Scratch(es), E - Replace	24,00

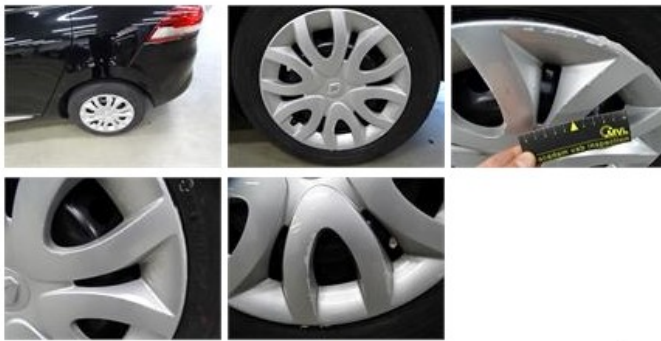
Wheel cover R L, Damaged, E - Replace 24,00
