SKODA Octavia: 1FAY499			
Vinnnumber:	TMBHT21Z7D2138504	Versionname:	OCTAVIA COMBI GTec Ambition DPF 105PK
First Registrationdate:	13/05/2013	Fiscalpower:	
Expertise Mileage:	142130	Power Kw:	77
Bodytype:	Break	Body color:	Black
Gearbox:	MAN 5 VIT	Paint type:	Metalic
Transmission:	Front	Rims summer:	Aluminium
Fueltype:	Diesel	Oil level:	OK
Battery functioning:	Yes	Parking lot:	3201
Number of doors:	5		
Number of seats:	5		
Number head rests:	5		
Rims summer:	Aluminium		
Category:	Passenger Car		
Oil level:	OK

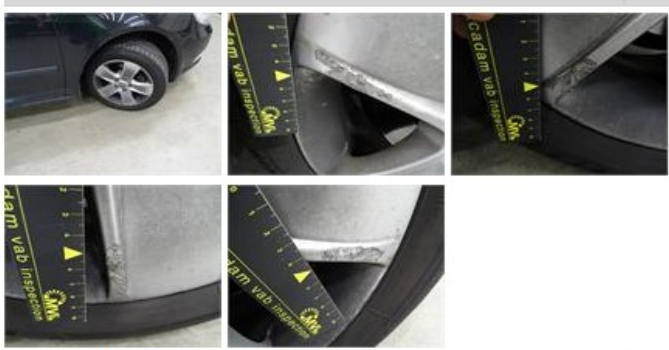
Assistance equipment			
Spare wheel	Yes	Jack	Yes
Total cost ex VAT			1410,71
Alloy rim F R, Scratch(es), LI - Repair and paint (complete)			95,00
