TOYOTA AYGO: ML0979			
Vinnnumber:	JTDKGNEC70N136567	Versionname:	1.0 VVT-I X-PLAY MMT
First Registrationdate:	1/01/2020	Fiscalpower:	
Expertise Mileage:	34763	Power Kw:	51
Bodytype:		Body color	Black
Gearbox:	Automatic	Paint type	Metalic
Transmission:		Rims summer	Steel
Fueltype:	Petrol	Oil level	OK
Battery functioning	Yes	Parking lot	3804
Number of doors	5		
Number of seats	4		
Number head rests	4		
Rims summer	Steel		
Category	Passenger Car		
Oil level	OK

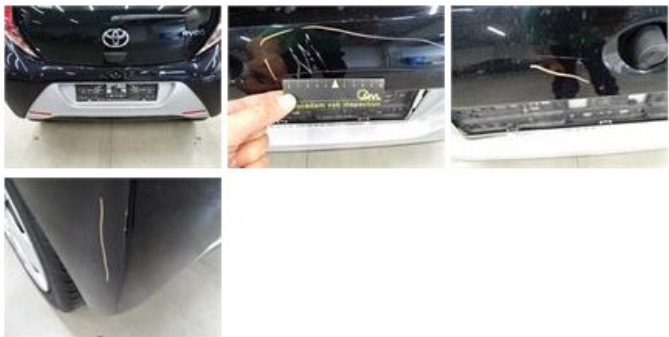
Assistance equipment	
Repair kit	Yes
Compressor	Yes
Total cost ex VAT	1048,00
Wheel cover R R, Scratch(es), Acceptable	0,00
<i>No pictures to display</i>	
Bumper R, Scratch(es), LI - Repair and paint (complete)	169,44
