OPEL Astra: 1DGB398

Limited Technical Inspection

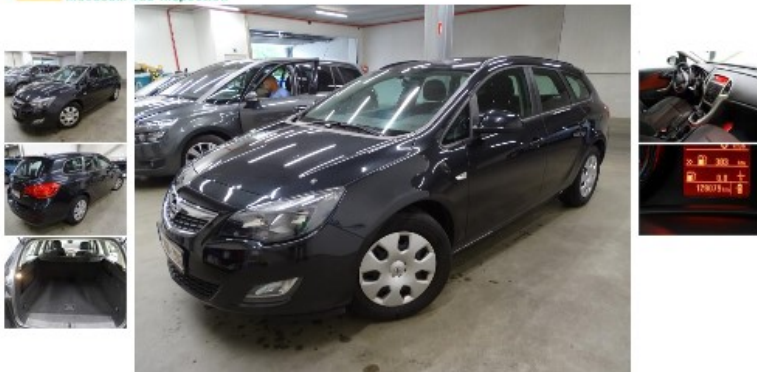
Total cost ex VAT	501,88
Rear spoiler, Bump(s), Acceptable	0,00
<i>No pictures to display</i>	
Wing R L, Scratch(es), Acceptable	0,00
<i>No pictures to display</i>	
Tailgate, Scratch(es), Acceptable	0,00
<i>No pictures to display</i>	
Bumper R, Bump(s) and scratch(es), LI - Repair and paint (complete)	211,80
