SEAT LEON ST: 1KDS145

Limited Technical Inspection

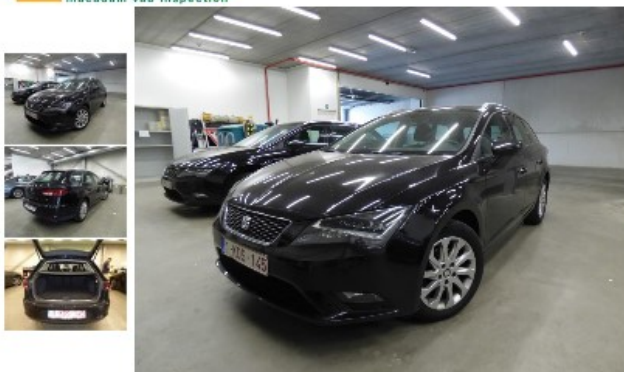
Vinnumber:	VSSZZ5FZFR090436	Versionname:	1.6 TDI 77KW STYLE
First Registrationdate:	9/04/2015	Fiscalpower:	
Expertise Mileage:	165529	Power Kw:	77
Bodytype:		Body color:	Black
Gearbox:	MAN 5 VIT	Paint type:	Metalic
Transmission:	Front	Rims summer:	Aluminium
Fueltype:	Diesel	Oil level:	OK
Maintenance:	OK	Parking lot:	1325
Battery functioning:	Yes		
Number of doors:	5		
Number of seats:	5		
Number head rests:	5		
Rims summer:	Aluminium		
Category:	Passenger Car		
Oil level:	OK		
Registration Certificate Car (BE):	Yes
