VOLKSWAGEN Touran: 1FGF682			
Vinnumber:	WVGZZZ1TZEW003349	Versionname:	TOURAN Trendline BMT Start/Stop 105PK
First Registrationdate:	20/06/2013	Fiscalpower:	
Expertise Mileage:	113875	Power Kw:	77
Bodytype:	Hatchback	Body color:	Dark Blue
Gearbox:	MAN 6 VIT	Paint type:	Metalic
Transmission:	Front	Rims summer:	Aluminium
Fueltype:	Diesel	Oil level:	OK
Battery functioning:	Yes	Parking lot:	1330
Number of doors:	5		
Number of seats:	5		
Number head rests:	5		
Rims summer:	Aluminium		
Category:	Passenger Car		
Oil level:	OK

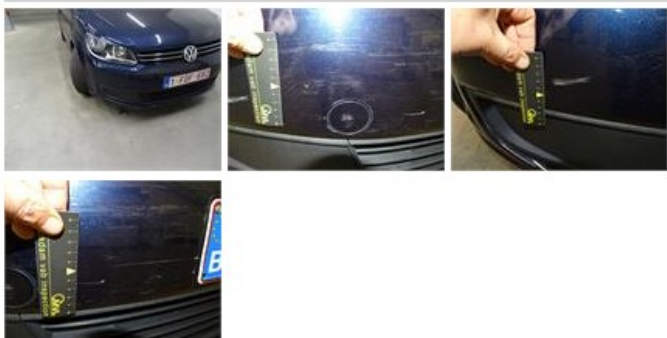
Assistance equipment			
Repair kit	Yes	Compressor	Yes
Total cost ex VAT			530,15
Front bumper, Scratch(es), LI - Repair and paint (complete)			211,80
