VOLKSWAGEN Golf: 1GWJ321

Limited Technical Inspection

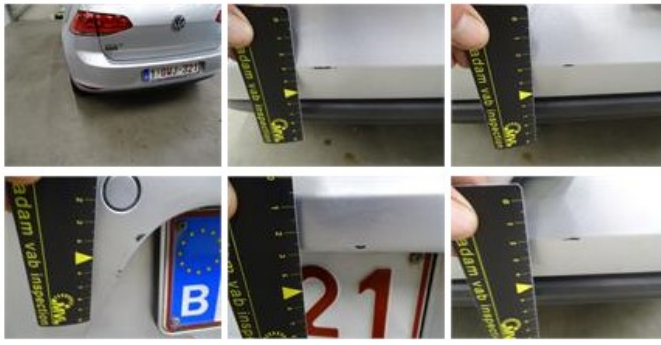
Total cost ex VAT	361,80
Tailgate, Bump(s), Acceptable	0,00
<i>No pictures to display</i>	
Bonnet, Stone chip(s), Acceptable	0,00
<i>No pictures to display</i>	
Roof, Bump(s), Acceptable	0,00
<i>No pictures to display</i>	
Wing R R, Bump(s), Acceptable	0,00
<i>No pictures to display</i>	
Certificate Of Conformity, Missing, E - Replace	150,00
<i>No pictures to display</i>	
Bumper R, Scratch(es), LI - Repair and paint (complete)	211,80
