VOLKSWAGEN GOLF VII: 1PBK716

Limited Technical Inspection

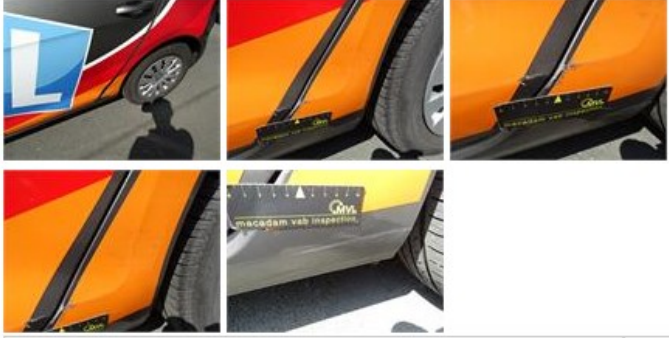
<i>No pictures to display</i>		
Door R R, Scratch(es), Acceptable		0,00
<i>No pictures to display</i>		
Wing R L, Scratch(es), LI - Repair and paint (complete)		308,20
