VOLKSWAGEN Passat: 1HAB016

Limited Technical Inspection

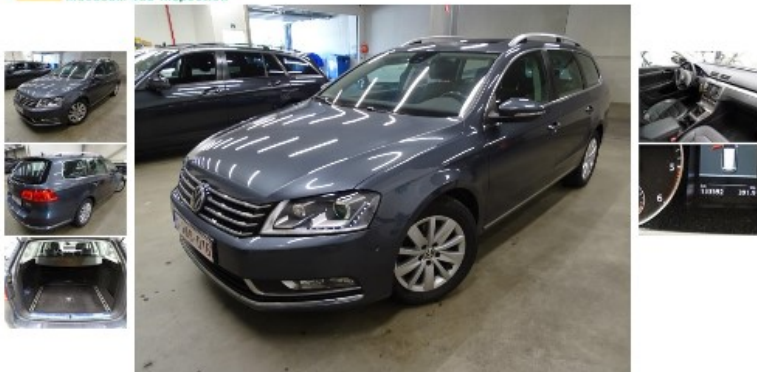
Vinnnumber:	WVWZZZ3CZEE164612	Versionname:	PASSAT VAR Comfortline
First Registrationdate:	2/06/2014	Fiscalpower:	136PK
Expertise Mileage:	133592	Power Kw:	100
Bodytype:	Break	Body color:	Dark Grey
Gearbox:	MAN 6 VIT	Paint type:	Metalic
Transmission:	Front	Rims summer:	Aluminium
Fueltype:	Diesel	Oil level:	OK
Battery functioning:	Yes	Parking lot:	4413
Number of doors:	5		
Number of seats:	5		
Number head rests:	5		
Rims summer:	Aluminium		
Category:	Passenger Car		
Oil level:	OK		
Registration Certificate Car (BE):	Yes
