VOLKSWAGEN Golf: 1GRS204

Limited Technical Inspection

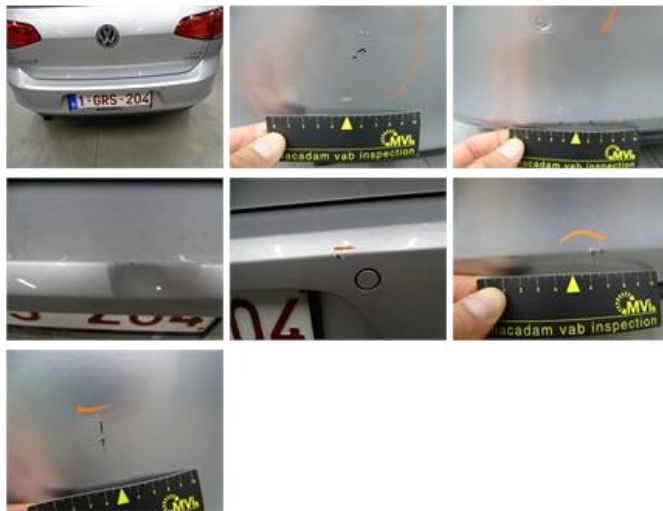
Total cost ex VAT	211,80
Rearview mirror housing L, Scratch(es), Acceptable	0,00
<i>No pictures to display</i>	
Door R R, Scratch(es), Acceptable	0,00
<i>No pictures to display</i>	
Wheel cover F R, Scratch(es), Acceptable	0,00
<i>No pictures to display</i>	
Door F L, Scratch(es), Acceptable	0,00
<i>No pictures to display</i>	
Bumper R, Scratch(es), LI - Repair and paint (complete)	211,80
