**AUDI Q5: 1HTP603**

**Limited Technical Inspection**

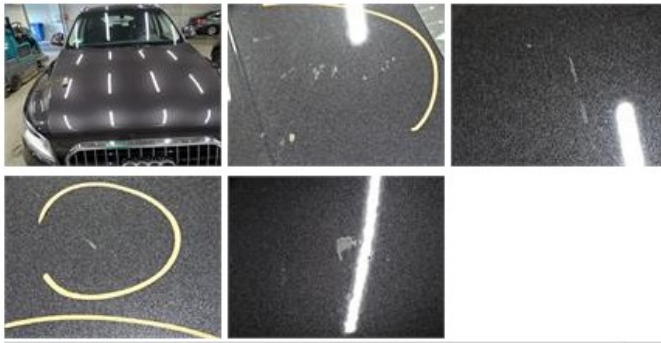
Emergency spare wheel	<b>Yes</b>	Compressor	<b>Yes</b>
Total cost ex VAT			<b>348,09</b>
Alloy rim F R, Scratch(es), Acceptable			<b>0,00</b>
<i>No pictures to display</i>			
Bumper R, Scratch(es), Acceptable			<b>0,00</b>
<i>No pictures to display</i>			
Door R L, Scratch(es), Acceptable			<b>0,00</b>
<i>No pictures to display</i>			
Wing F L, Stone chip(s), Acceptable			<b>0,00</b>
<i>No pictures to display</i>			
Bonnet, Chemical polution, LI - Repair and paint (complete)			<b>348,09</b>
