BMW 3: 1HXH500

Limited Technical Inspection

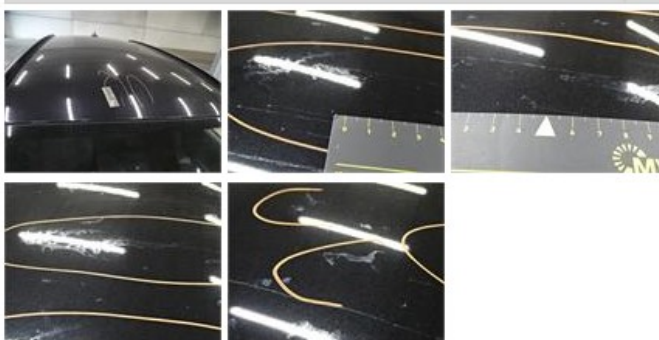
Repair kit	Yes	Compressor	Yes
Total cost ex VAT			789,70
Roof, Chemical polution, LI - Repair and paint (complete)			481,50
