MINI Mini: 1FXB807			
Vinnnumber:	WMWSW11020T771969	Versionname:	MINI One D 90PK DPF
First Registrationdate:	25/11/2013	Fiscalpower:	
Expertise Mileage:	144546	Power Kw:	66
Bodytype:		Body color	Black
Gearbox:	MAN 6 VIT	Paint type	Metalic
Transmission:	Front	Rims summer	Steel
Fueltype:	Diesel	Oil level	OK
Maintenance	IN 2100 KM		
Maintenance	OK		
Battery functioning	Yes		
Number of doors	3		
Number of seats	4		
Number head rests	4		
Rims summer	Steel		
Category	Passenger Car		
Oil level	OK		
Registration Certificate Car (BE)	No

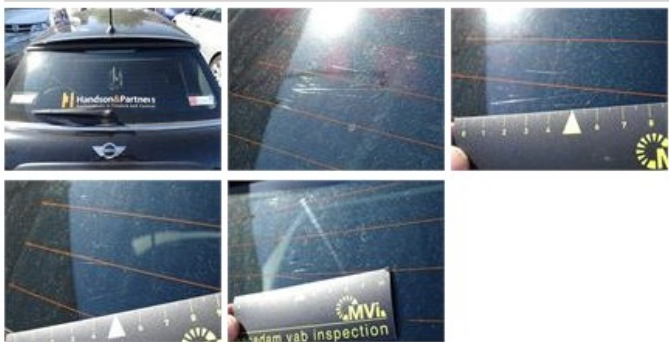
Assistance equipment			
Repair kit	Yes	Compressor	Yes
Total cost ex VAT			458,80
Rear window, Scratch(es), E - Replace			370,00
