RENAULT GRAND SCENIC: 1KVR898

Limited Technical Inspection

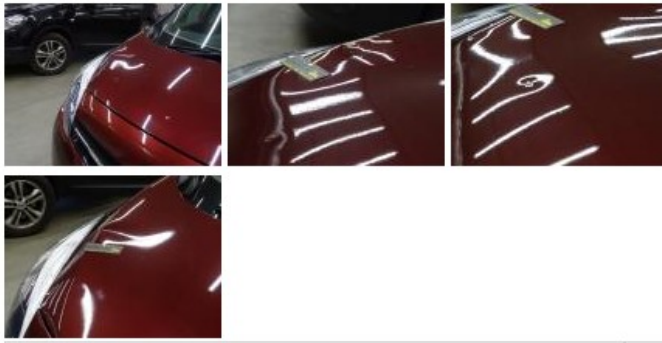
SD card, Missing, E - Replace	275,00
<i>No pictures to display</i>	
Door F R, Bump(s), Acceptable	0,00
<i>No pictures to display</i>	
Wing R R, Scratch(es), Acceptable	0,00
<i>No pictures to display</i>	
Bonnet, Bump(s) and scratch(es), LI - Repair and paint (complete)	434,08
